Manhole Inspection Summary

Manhole # S29KK1008MH

Insp Date: **4/26/07 12:09 PM**

Location Address: **119 OVERHILL RD**

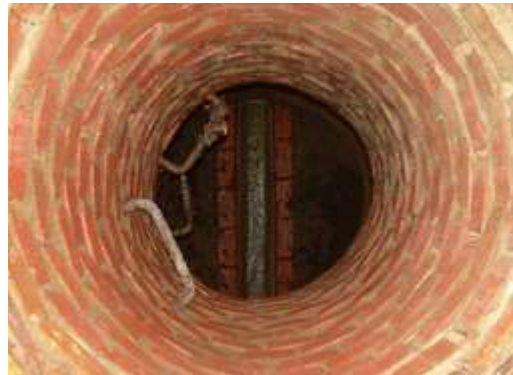
Top View

Bench ☒ Exists Material: **Brick** ☐ Parged ☒ **Debris** (not Condition related)

Steps Count: **5** Missing: **0** ☒ **Corroded**

Corroded steps. Bench debris.

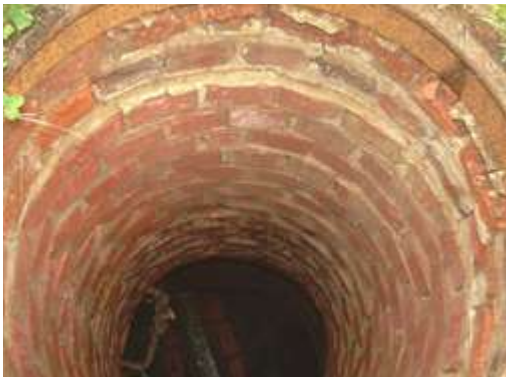
Defect

Condition: ☐ Sound ☐ Cracked ☐ Root Intrusion ☒ **Loose Brick** ☒ **Deteriorated**

Infiltration: ☐ None ☒ **Joint** ☐ Cracks ☒ **Mortar** ☐ Roots ☐ Wall

Infiltration: ☐ None ☐ Joint ☐ Cracks ☒ **Mortar** ☐ Roots ☒ **Wall**

Adjustment deterioration, loose brick and infiltration. Barrel infiltration.

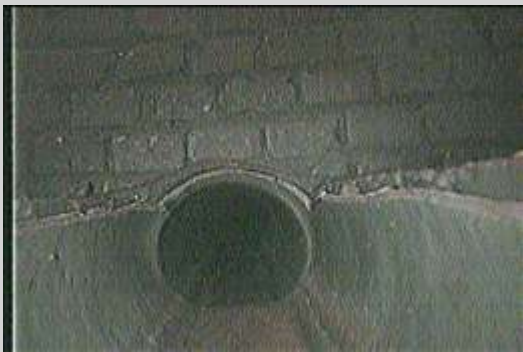
8 in. Circular Gravity Sewer Pipe Out @ 12 O'Clock

Pipe Material: **Unknown** ☒ Pipe Lined

Invert Depth: **11.29** (ft.) Flow Characteristics: **Fast**

Deposits: ☒ None ☐ Mud ☐ Sludge ☐ Debris ☐ Grease

Infiltration: **None** Pipe Seal Cond: **Unknown**

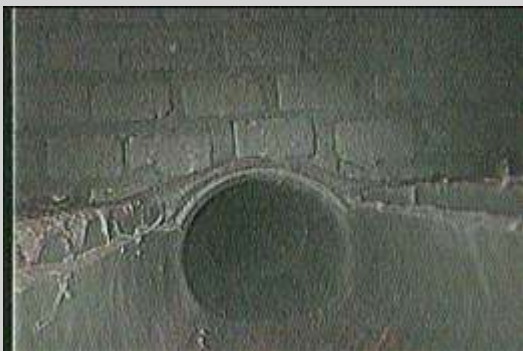
8 in. Circular Gravity Sewer Pipe In @ 6 O'Clock

Pipe Material: **Unknown** ☒ Pipe Lined

Invert Depth: **11.22** (ft.) Flow Characteristics: **Fast**

Deposits: ☒ None ☐ Mud ☐ Sludge ☐ Debris ☐ Grease

Infiltration: **None** Pipe Seal Cond: **Unknown**
